PV module quality control and testing: using data and analysis to enhance safety and performance

Ensuring PV Manufacturing Quality

A guide to the most common
quality issues in module manufacturing

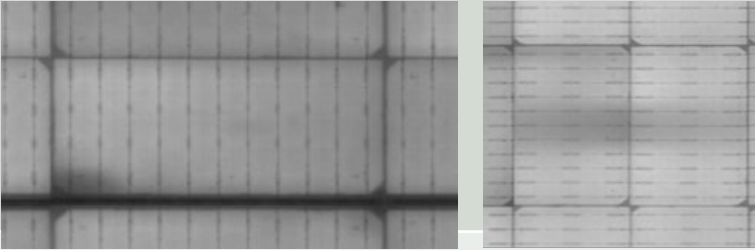
Defect	Description	Example
Cold soldering	Occurs due to poor electrical contact between the cell and the ribbon during soldering. Higher resistivity leads to dark areas.

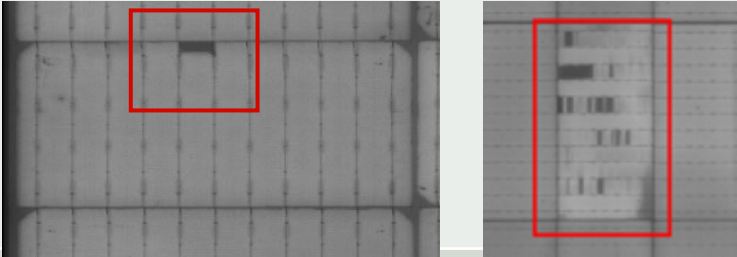
Grid breaks	Defective metallization during screen printing of cell fingers causes higher resistivity areas where the metallization is lacking. These areas appear darker.

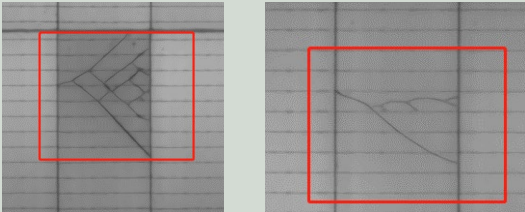
Microcracks	Cracks in the cell cause electrical discontinuity and loss of active area leading to dark lines appearing. Stresses can cause the cracks to grow and branch.

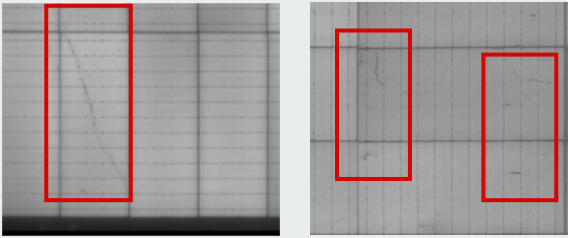
Cell scratch	Scratched cell surface causes lower efficiency and leads to dark lines appearing.

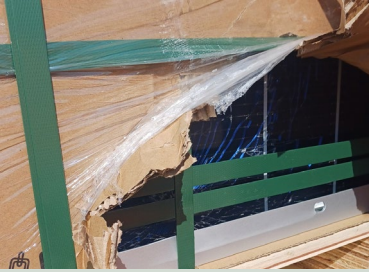
Description	Example
Damaged packing

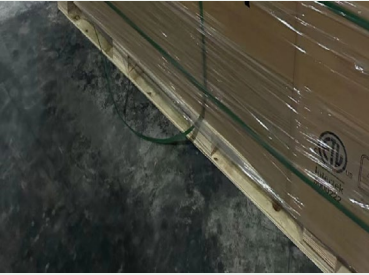
Torn fixing tie

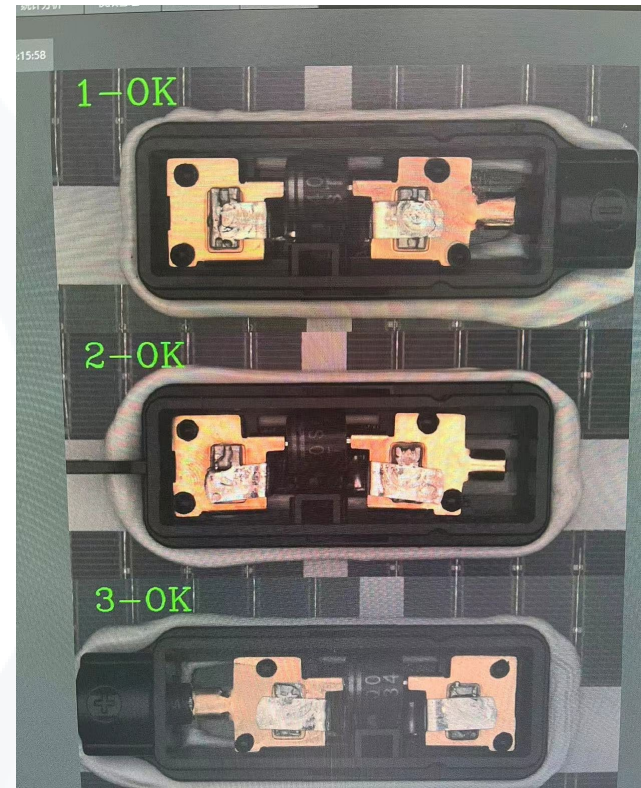
There has been an increase in thermal events (fires) in PV modules linked to poor junction box soldering quality. CEA found that the current soldering inspection methods at some factories were not effective in detecting these defects and required suppliers to strengthen controls by closely monitoring resin, flux, and solder ratios and implementing 100% physical inspections.

As more PV factories adopt automated soldering and inspection for junction boxes, there has been a trend to reduce or eliminate physical inspections. This has led to inconsistent soldering quality because automated checks alone are not enough to catch all defects. Some manufacturers were found to be trying to bypass physical inspections on 100% of the junction boxes, which allowed these issues to go undetected.

Defective soldering in junction boxes can increase the risk of thermal events or fire, which can cause severe damage to the module, pose safety hazards, and lead to costly replacements.

AI supported visual auto-inspection of junction boxes

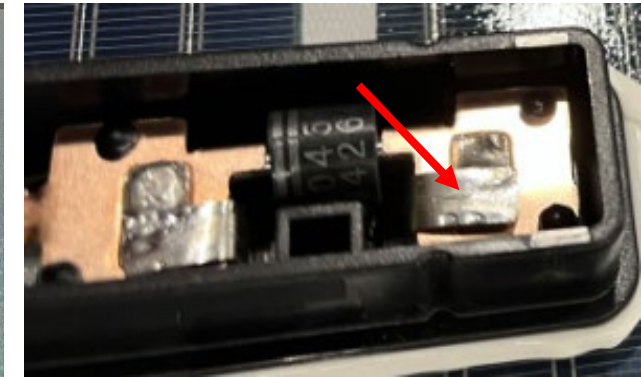
Unsoldered terminal

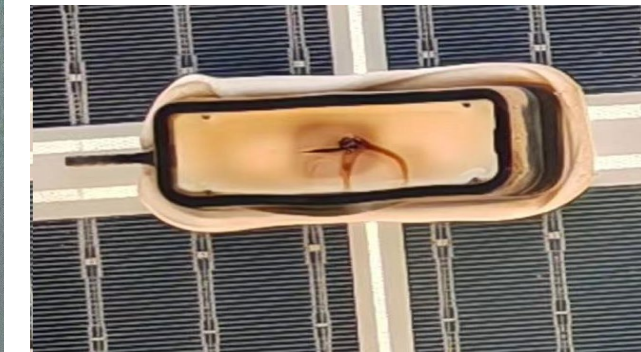
Burnt and damaged junction box

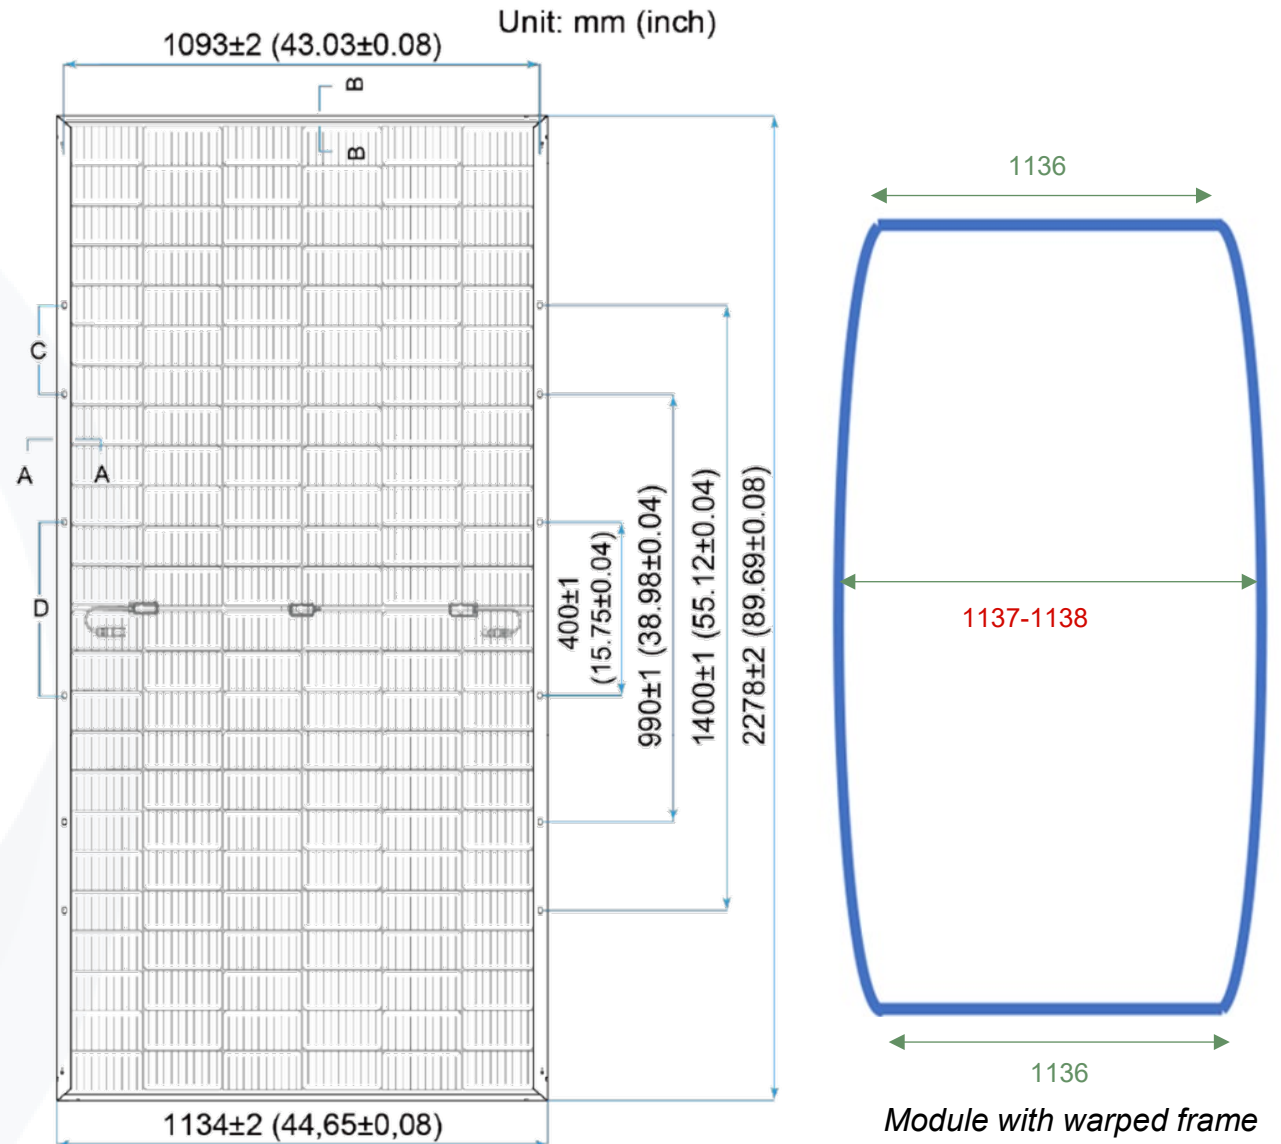
Auditors found that the module dimensions were out of specification when measured on the front side, while they appeared within specification when measured on the rear side. CEA identified 111 non-conforming products. Subsequently, we repeated the inspection on the whole batch to prevent unqualified modules from being shipped.

When the production line changed to modules with a larger frame thickness, the framing machine parameters need to be adjusted to the new frame thickness. But based on the records checked by CEA, the supplier did not adjust the machine settings properly and no checks were done. Due to the wrong machine setting, the frames became warped, leading to variations in module dimensions.

The dimension discrepancy may lead to the rack row having insufficient spacing for thermal expansion or to fit all modules in a row.

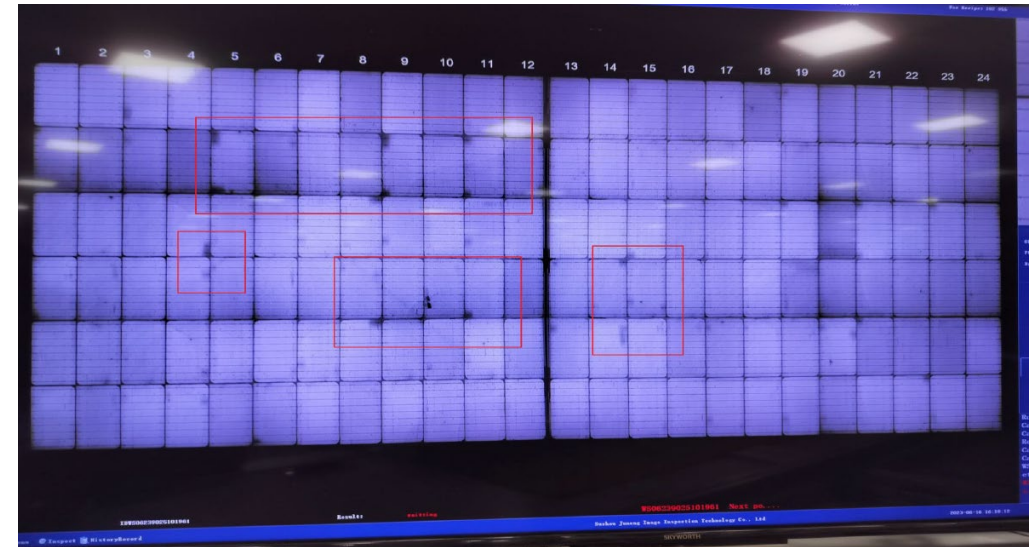
During IPM, an inspector found several defects at the electroluminescence (EL) imaging station and noted down the serial numbers of the affected modules. However, when checking these same modules during Pre-Shipment Inspection (PSI), the EL images provided by the supplier showed no defects. This raised concerns that the images might have been altered, indicating suspicious behavior during the factory inspections.

Most suppliers have good ethics, but in rare cases, CEA has observed misconduct. In this case, the supplier repeatedly delayed providing the EL images requested by CEA, providing various excuses. During PSI, it took 3 days for the inspector to start each inspection rather than the few hours typically needed. CEA detected that the EL data were tampered with to cover the fact that the supplier replaced defective samples to avoid lot rejection.

Shop floor EL with cold soldering

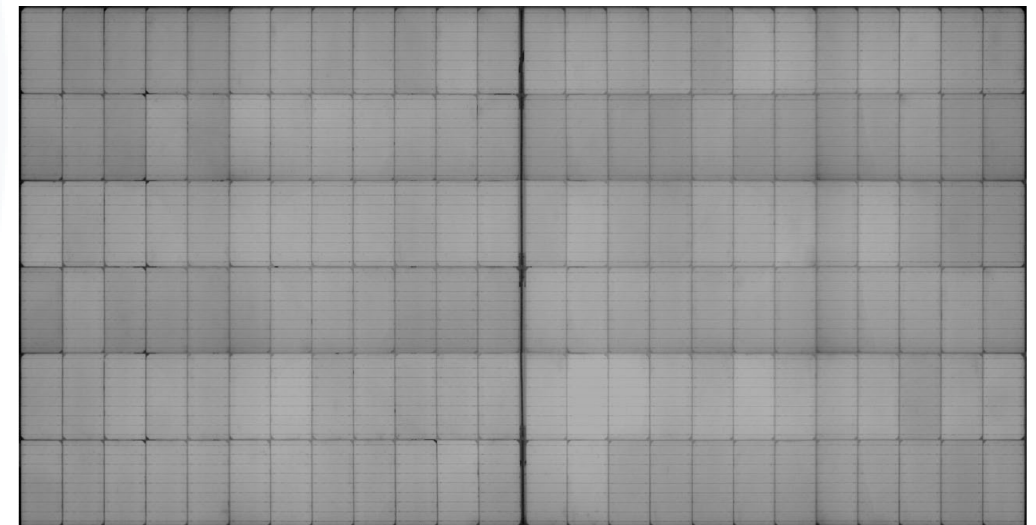
During PSI the same serial number module showed no cold soldering

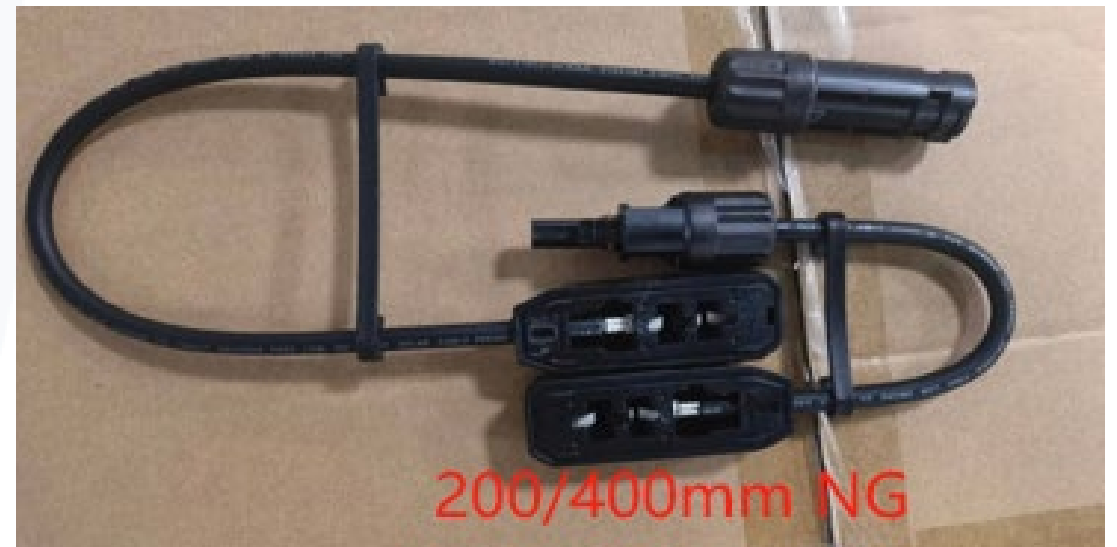
During an inspection at an Original Equipment Manufacturer (OEM), CEA found that the junction box cable length was incorrect. The inspector immediately asked the factory to stop production, isolate the affected modules, and track the work order to inspect the modules in the warehouse which were produced during the affected period.

- After investigation, it was found that the OEM factory changed the cable length without approval from the module supplier; the quality was not properly controlled in the OEM factory.
- The communication and authorization process was not followed by the OEM factory.

Significant module installation issues on site.

Incorrect junction box cable length of 200/400mm

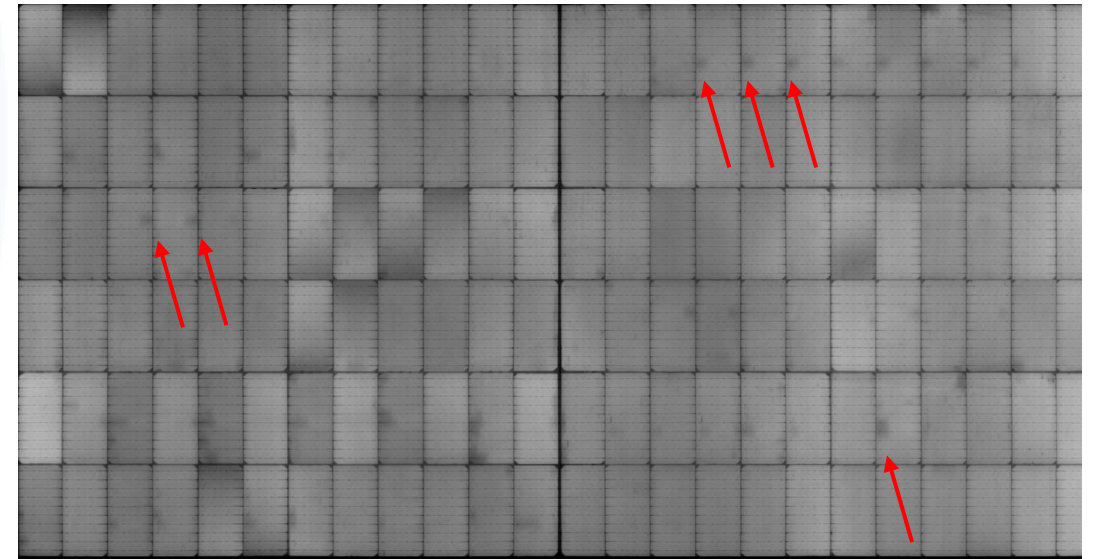
During the final electroluminescence (EL) inspection, the inspector found modules with cold soldering defects that the supplier had marked as 'pass'. Upon re-inspection, CEA found more defective modules from the same shift.

- The operator was temporarily assigned to this station without proper training and did not know the inspection standards.
- The root cause of the cold soldering was a dirty flux nozzle during the soldering process, which wasn't cleaned properly.

Modules with cold soldering defects could be shipped, leading to poor electrical connections, reduced performance, and potential early failure.

EL image with cold soldering defect

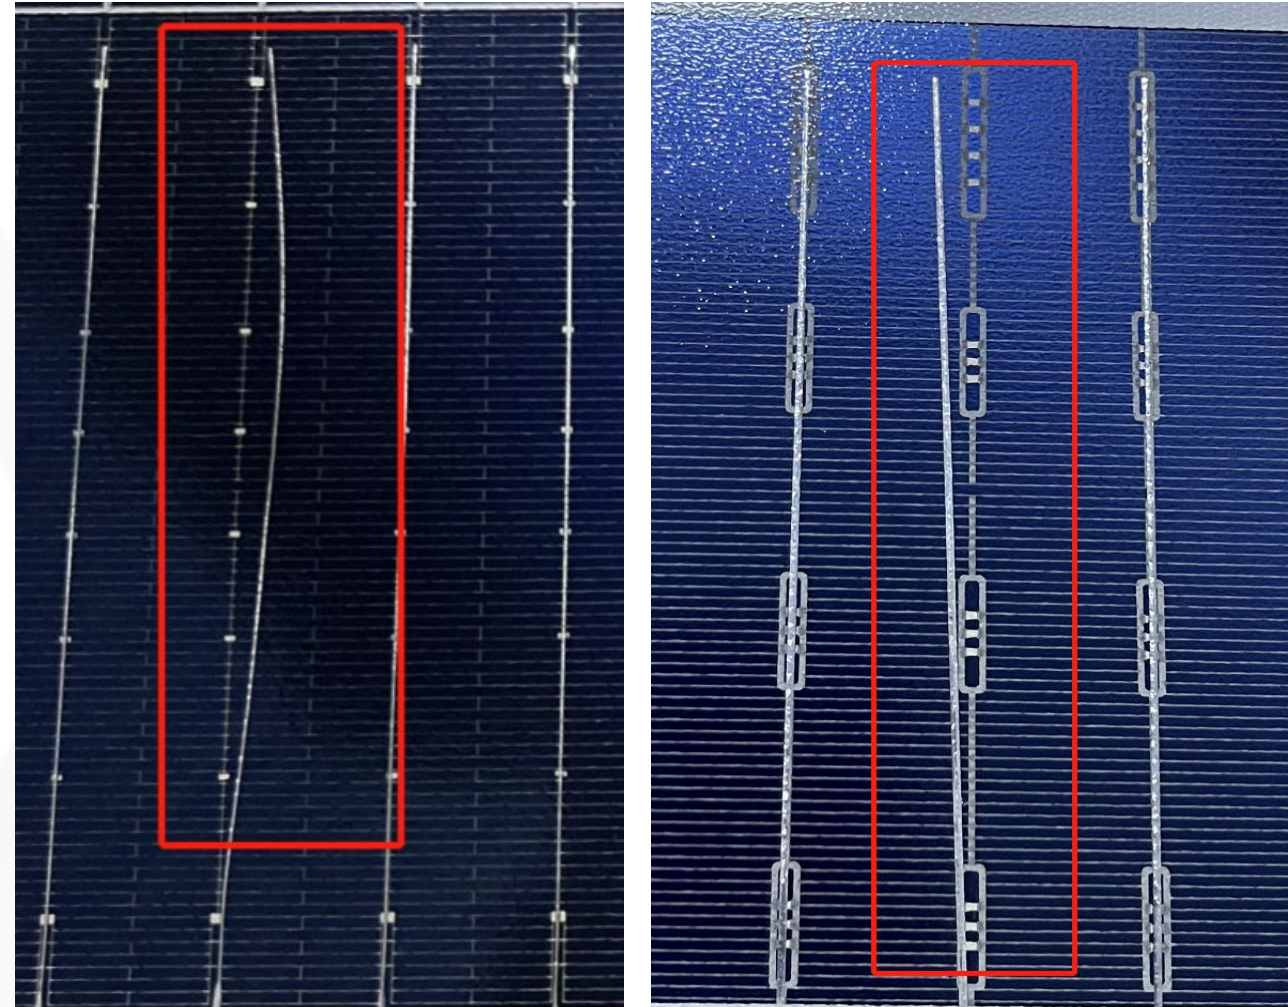
During the visual inspection, the inspector found that the cell interconnection ribbons were misaligned, but the supplier had marked these modules as 'pass' and sent them to the packing process. CEA isolated the affected modules to prevent unqualified products from being delivered to the client.

The misalignment occurred because one of the tabbers in the stringer machine wasn't cleaned properly, causing flux residue to crystallize. This prevented the interconnection ribbon from being securely held, resulting in the ribbon twisting and being soldered in the wrong position.

Misaligned ribbons can lead to poor electrical connections, which increase resistance, reduce module efficiency, and cause hotspots that may result in module failure or even safety hazards over time.

Ribbon misalignment

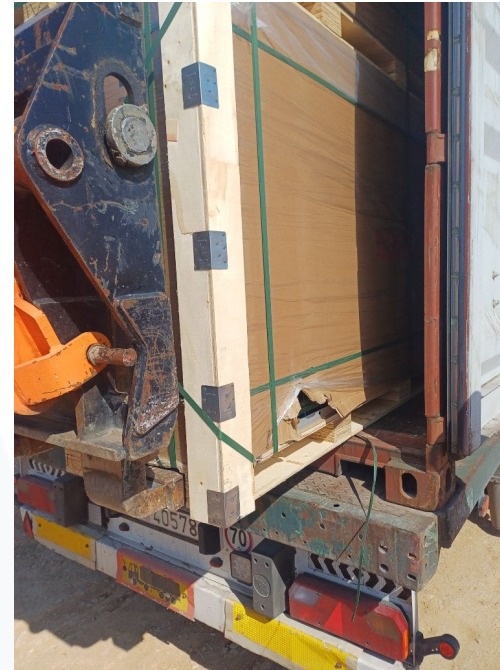
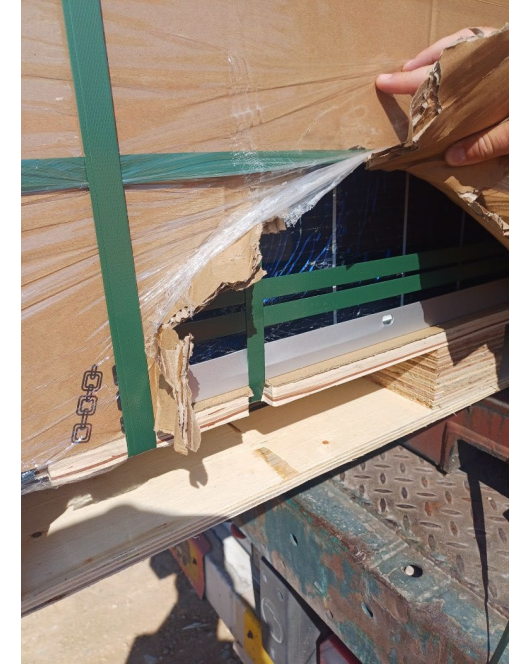
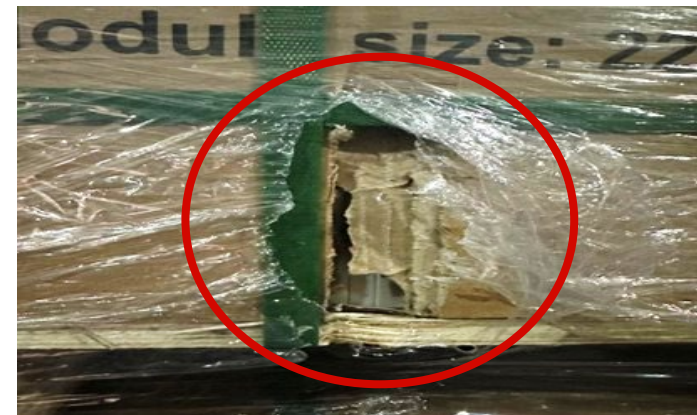
Inspector found that one pallet's packaging was damaged after loading. The inspector instructed the the supplier to halt loading and remove the damaged pallet. All module serial numbers were documented, and the modules underwent a re-inspection (visual, flash test, and EL inspection) to confirm no damage had occurred.

The damage occurred when the fork of the forklift accidentally hit the bottom of the pallet while lifting it, tearing the wrapping film and denting the carton box. However, the forklift operator continued loading without stopping to check the damage visually, as required by the standard operating procedure (SOP).

The damaged packaging could indicate potential hidden damage to the modules, leading to performance issues or defects that might not be visible but could compromise the modules' integrity and reliability during transport or installation.

Damaged packing
